The Segregation Wall impacts on Palestinian Environment

Applied Research Institute – Jerusalem

December 2015

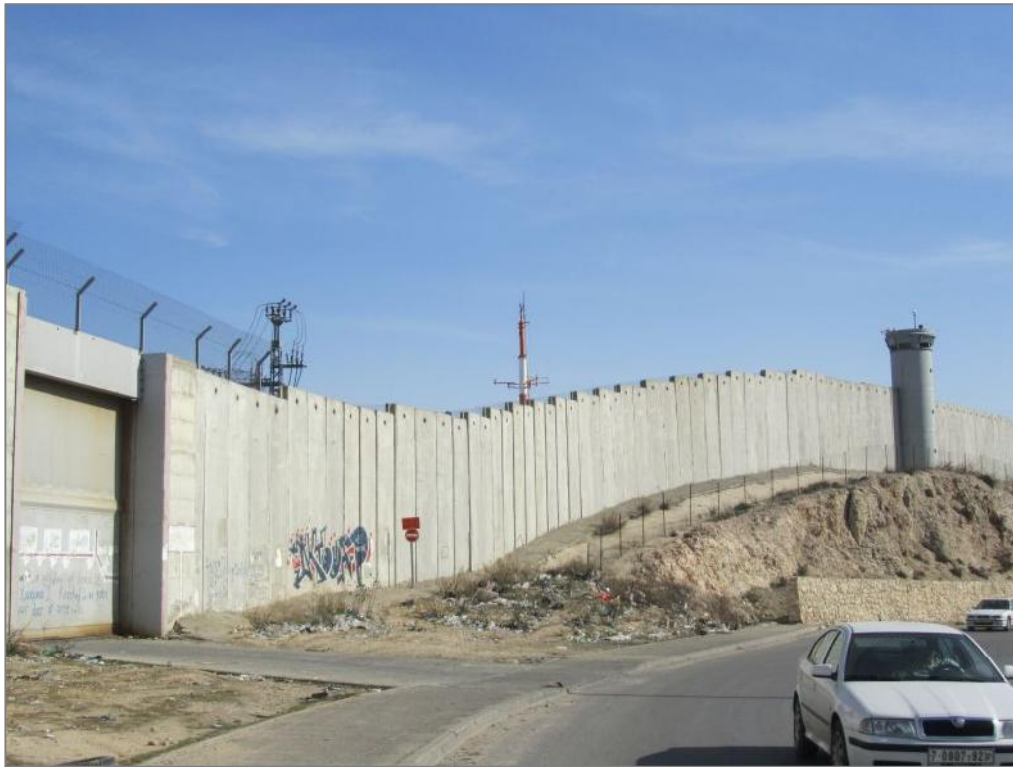
Photo 1: The Segregation Wall

At this time, an explanation of the nature of the "Segregation Wall" should be made. The wall includes two types of structures used by the Israeli Army to complete their territorial separation of Palestinian land; it is either made of concrete partitions 8-12 m in height or is made of wired fence. In either case, the term Segregation is used herein. The choice of structure is determined by the nature of the area the wall separates. For example, in areas where the Segregation Wall cuts through vast agriculture lands, it is a fence. The fence is in fact more devastating as it takes an area of a 40-100 m in width to complete, as it consists of double layered fences reinforced with barbed wire, trenches, military roads and footprint detection tracks, as well as 4-5 m high electrified metal fences with security surveillance cameras. In the other case, in areas with sizeable population and/or in-close proximity with the 1949 Armistice Line (the Green Line), the Segregation Wall consists of 8-12 m high concrete partitions with military watchtowers lined-up 250 m apart.

The construction of the Wall started in June 2002 West of Jenin. The wall is still under construction, and when completed, its length will be approximately 773 km. Up to date, 58.5% (or 452 km) of the wall was constructed, 8% (or 62 km) is under construction and 33.5% (259 km) is in planning phase (ARIJ database, 2015). The Wall is composed of vehicle-barrier trenches, exclusion zones, electric fences and thick concrete slabs stretching 8 meters high (Photo 1).

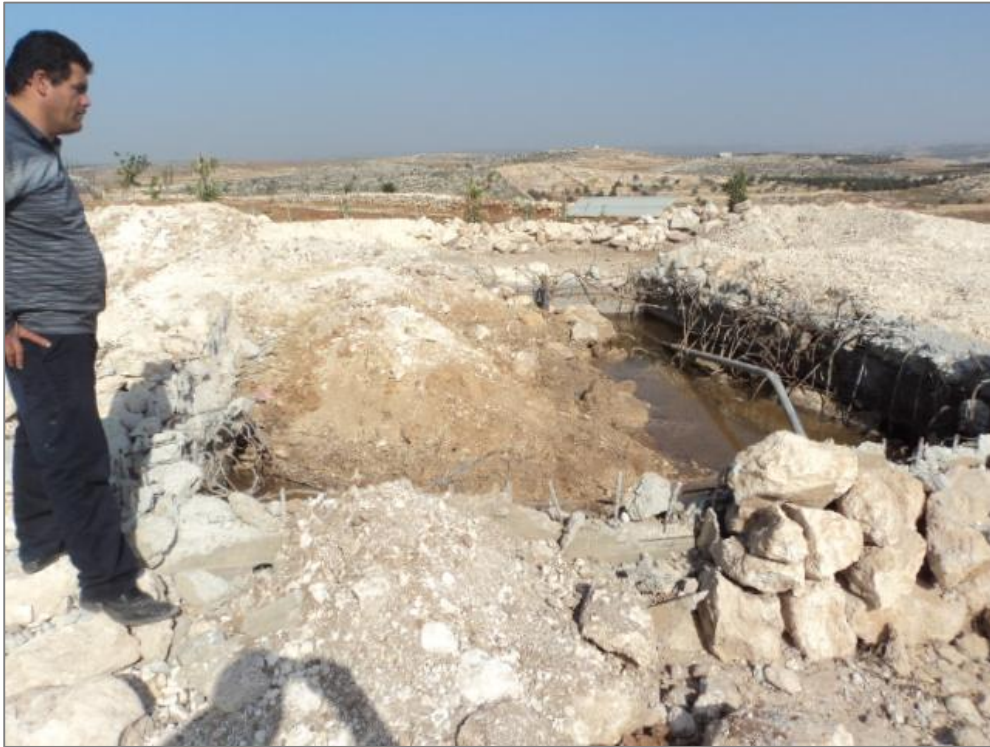
Photo 2: Demolished water well

The Segregation Wall construction has isolated wells, springs and cisterns, and damaged or destroyed water infrastructure, especially irrigation networks (Photo 2). Of the 173 directly affected communities⁵, 60 per cent reported that the Wall construction has impacted their domestic and/or agricultural water resources.

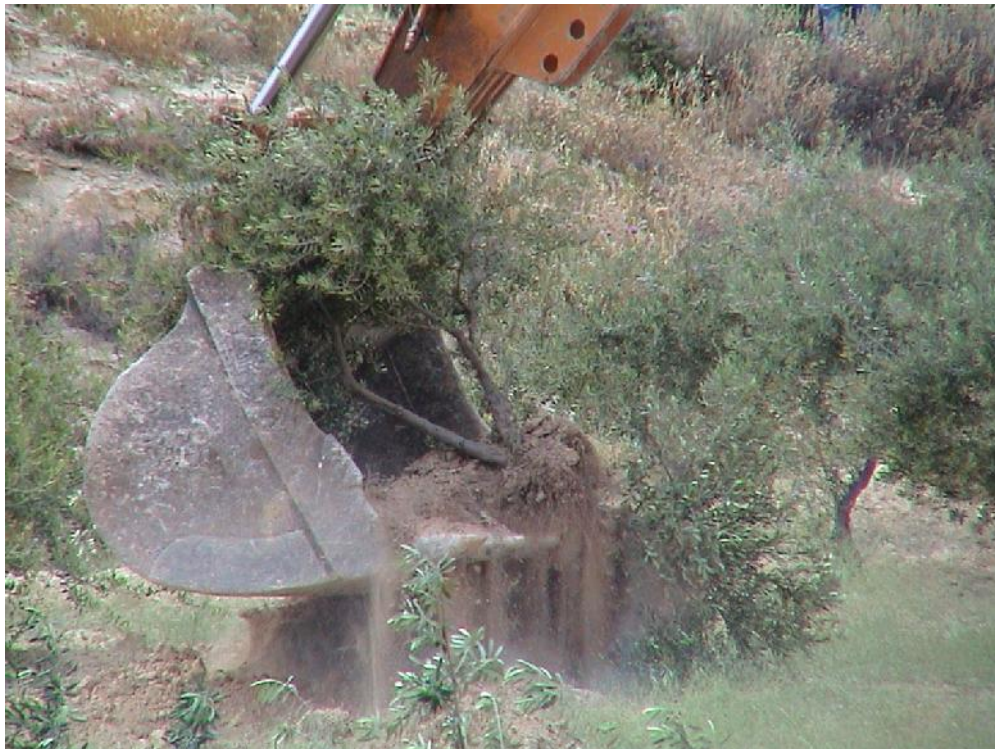
Photo 3: Uprooting of Olive trees to build the Segregation Wall

the Segregation Wall. In Qalqiliya city alone, about 12,000 olive, almond, and fruit trees were uprooted with detrimental impacts on farmers' incomes (ARIJ-UM, 2011)⁹.

In Marda village in Salfit Governorate, at least 1,000 dunums of agricultural and other potentially arable lands are expected to be confiscated or separated behind the Wall. In addition, about 1,000 long-lived olive trees which are considered the primary source of subsistence of the resource-poor farmers in the region have been either destroyed or uprooted. An additional 800 olive trees will also be separated behind the Wall (Photo 3). The same situation occurred in Zububa village in Jenin governorate, where more than 1,700 dunums of agricultural lands were confiscated and/or separated behind the Wall and around 1,500 olive and almond trees were uprooted. In Tayba village in Jenin governorate, 4,000 olive trees and 1,000 almond trees were uprooted (ARIJ database, 2015).

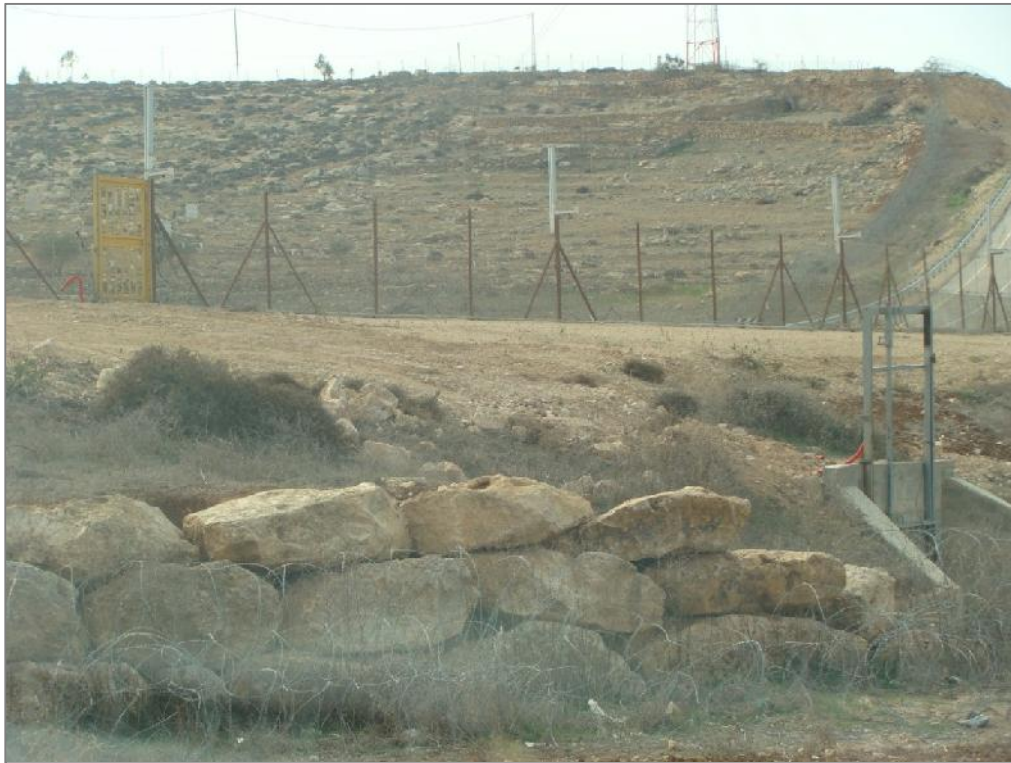
Photo 4: Agriculture Gate in Imnezil village in Hebron Governorate

Two-thirds of the 68 agricultural gates (Map 1) that control Palestinian access to land across the Segregation Wall are open for just one or two months per year during the annual olive harvest (Photo 4). Farmers are often not permitted to regularly access and maintain their

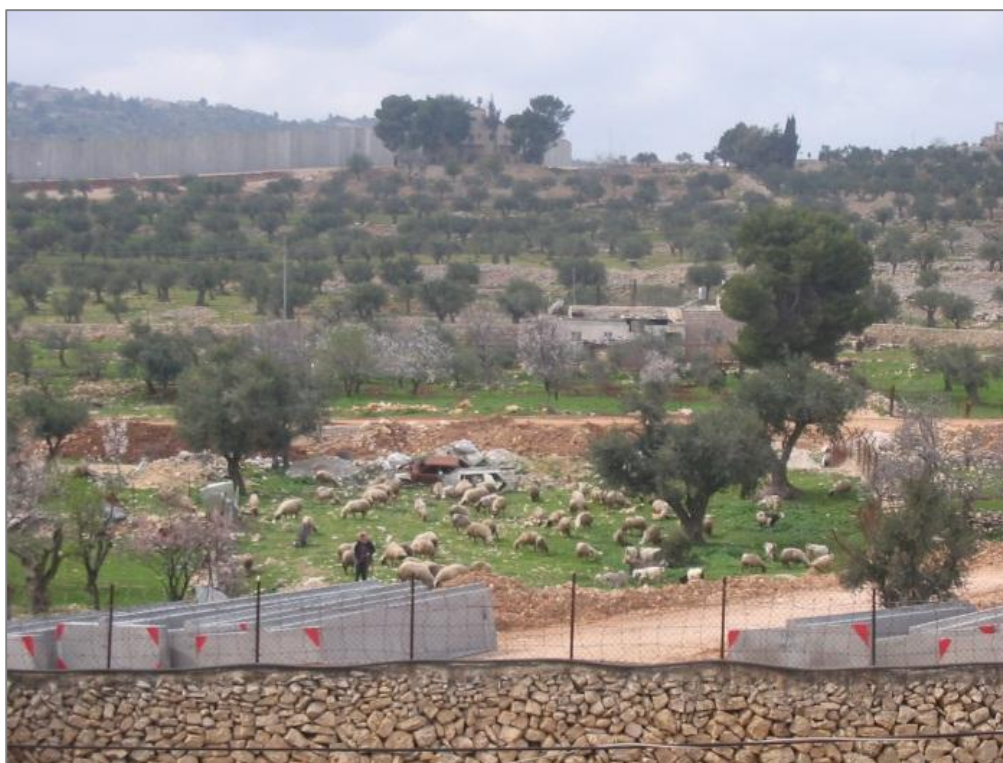
Photo 5: Fragmentation of agro-ecosystems in Bethlehem city, isolating residential houses from their agricultural lands and preventing sheep from grazing in lands located behind the Segregation Wall

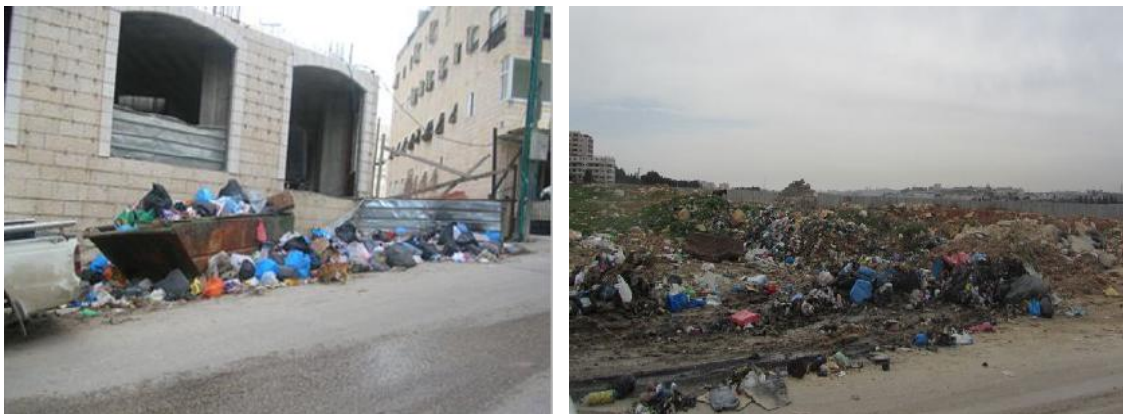
Photo 6: Accumulation of Solid waste in the affected communities

Waste disposal sites behind or close to the Segregation Wall were rendered inaccessible. Affected communities must now either transport their waste to distant sites at extra cost, or burn the waste within or in proximity to their residential areas, releasing toxic emissions into the air and leachate into soil and groundwater (Photo 6). Moreover, due to increased transportation costs, most villages have little choice but to burn their garbage within the community. Other villages have incurred additional costs from buying or renting alternate land for waste disposal.

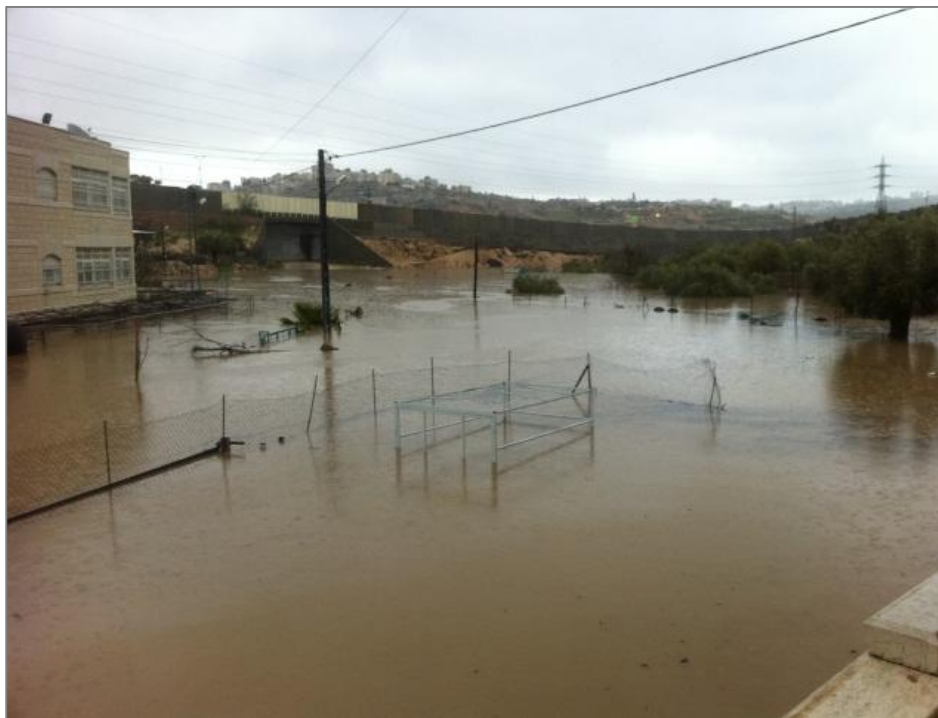
Photo 7: Blocked drainage causing water and wastewater flooding of residential areas and agricultural lands

The Segregation Wall's construction also affected sewage and water drainage networks. Drainage channels built under the Segregation Wall can become blocked by debris or during winter times when heavy rains occur (Photo 7). However, Palestinians are not permitted to approach the Segregation Wall to clear blockages due to security restrictions imposed by Israel, leading to sewage waste overflow onto adjacent lands such as in Qalqiliya and Ar Ram and Dahiyat al Bared localities, which cause soil contamination and increases health risks with water-borne diseases.
